**NIST NCSTAR 1-2B**

**Federal Building and Fire Safety Investigation of the  
World Trade Center Disaster**

# **Analysis of Aircraft Impacts into the World Trade Center Towers Chapters 9, 10, 11 & Appendix A**

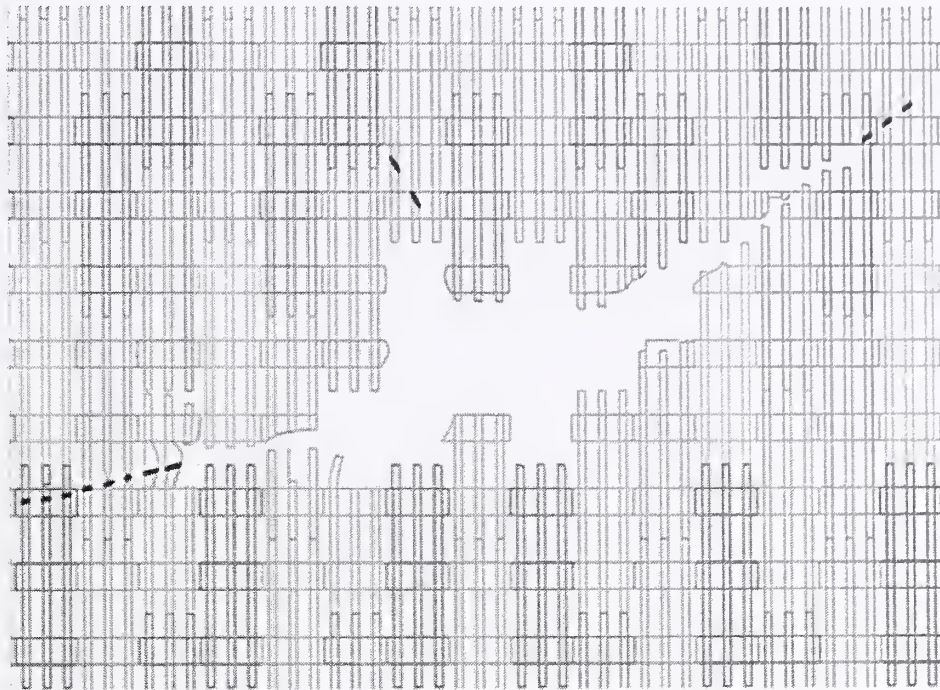
Figure 9–49. More severe impact damage to the WTC 1 exterior wall.

(a) Schematic of observed damage

(b) Calculated damage ( $t=0.685$  s)
